### **Subject: Public Footpath P5/8/1 known as Station Terrace Level Crossing**

Station Terrace Level Crossing

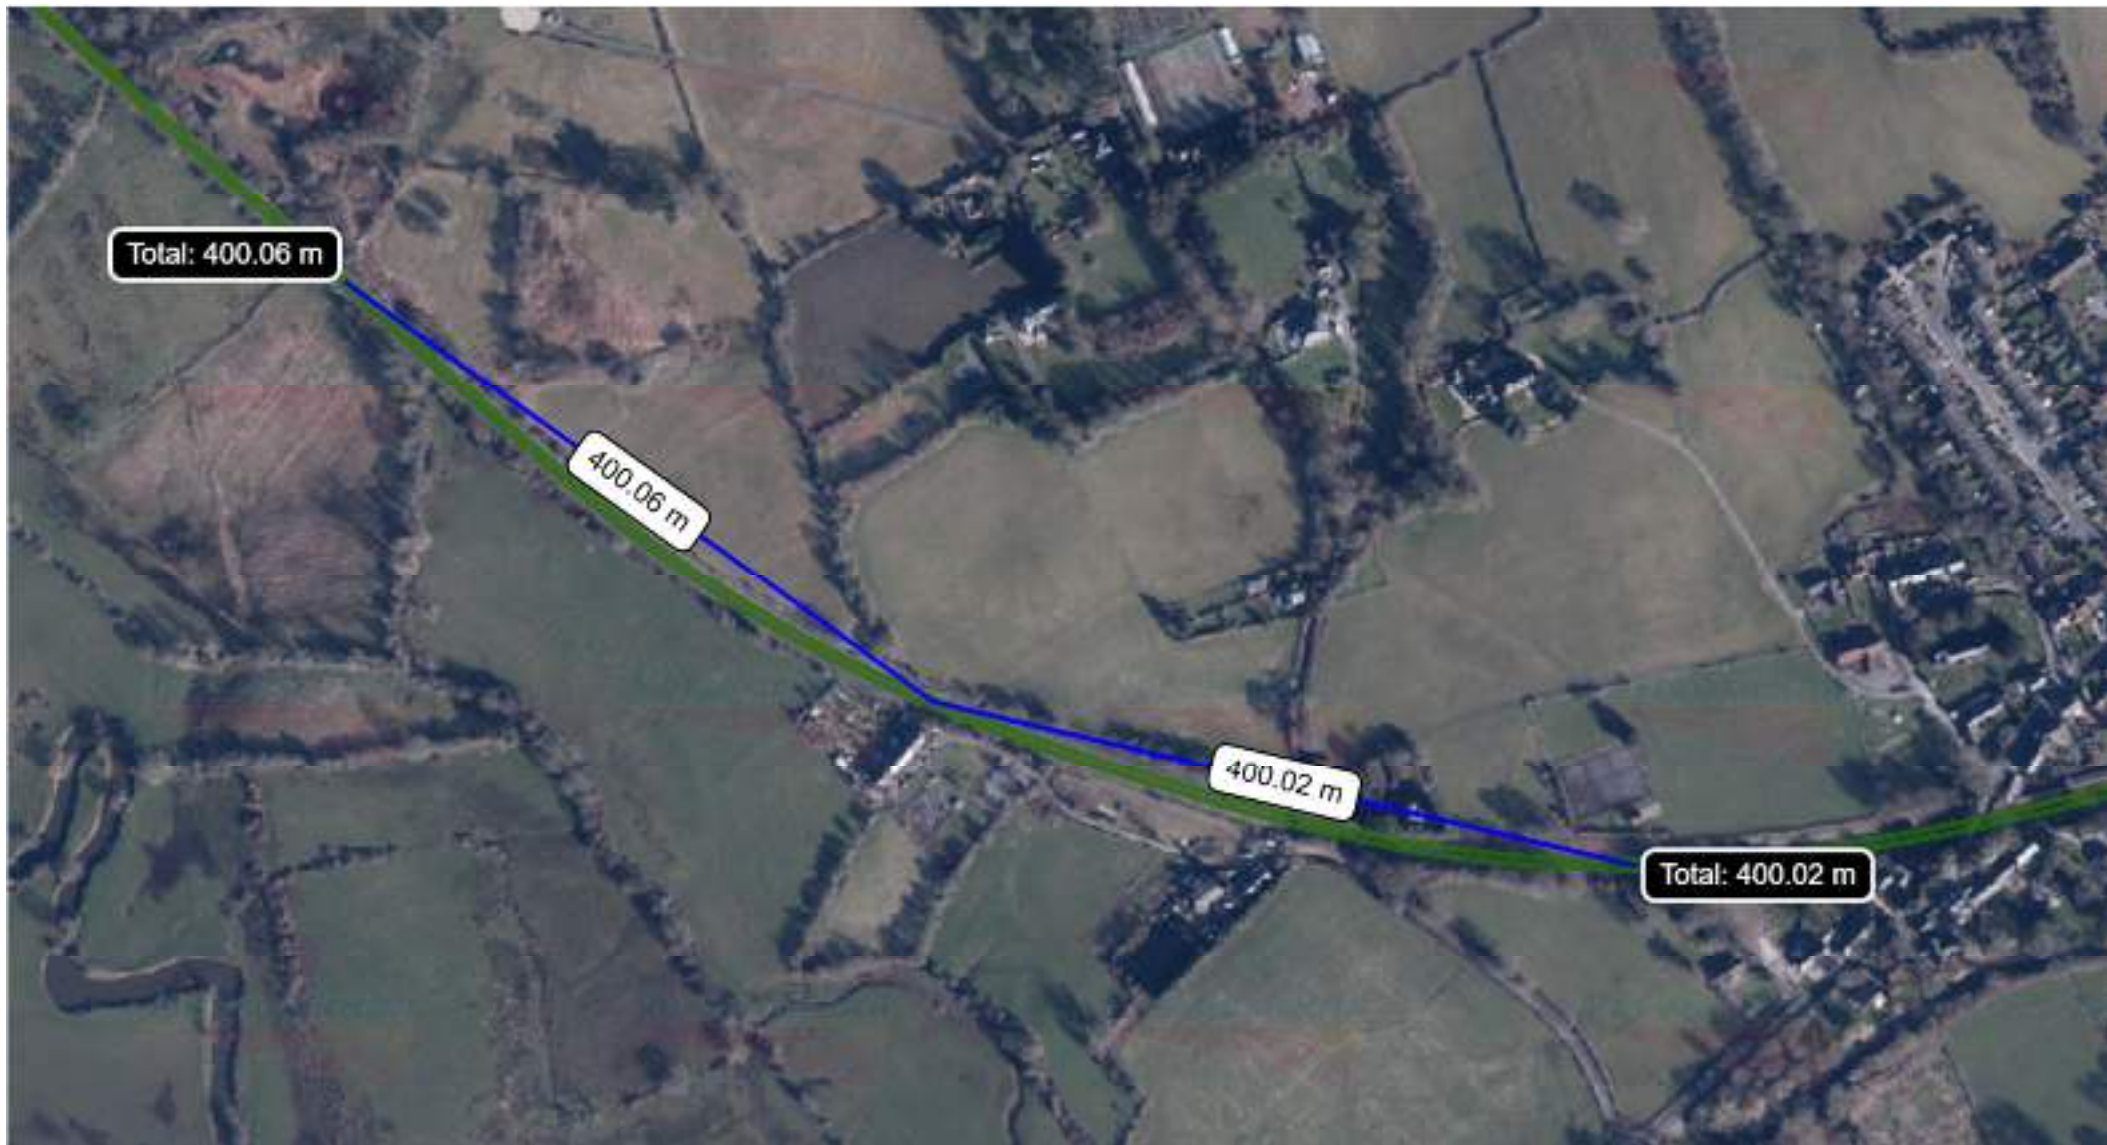
Potential Whistle Board locations – 400m either side of the level crossing

Whistle boards would need to be positioned approximately 400 metres on either approach to the crossing, near lineside residential properties, please see approximate location plan further in this pack. With 236 train movements per weekday, with a slight reduction on weekends over this section of railway, this would result in a significant and sustained increase in noise levels, giving rise to considerable noise pollution and likely adverse impact on local residents amenity and quality of life. Please see the accompanying plan showing the approximate location

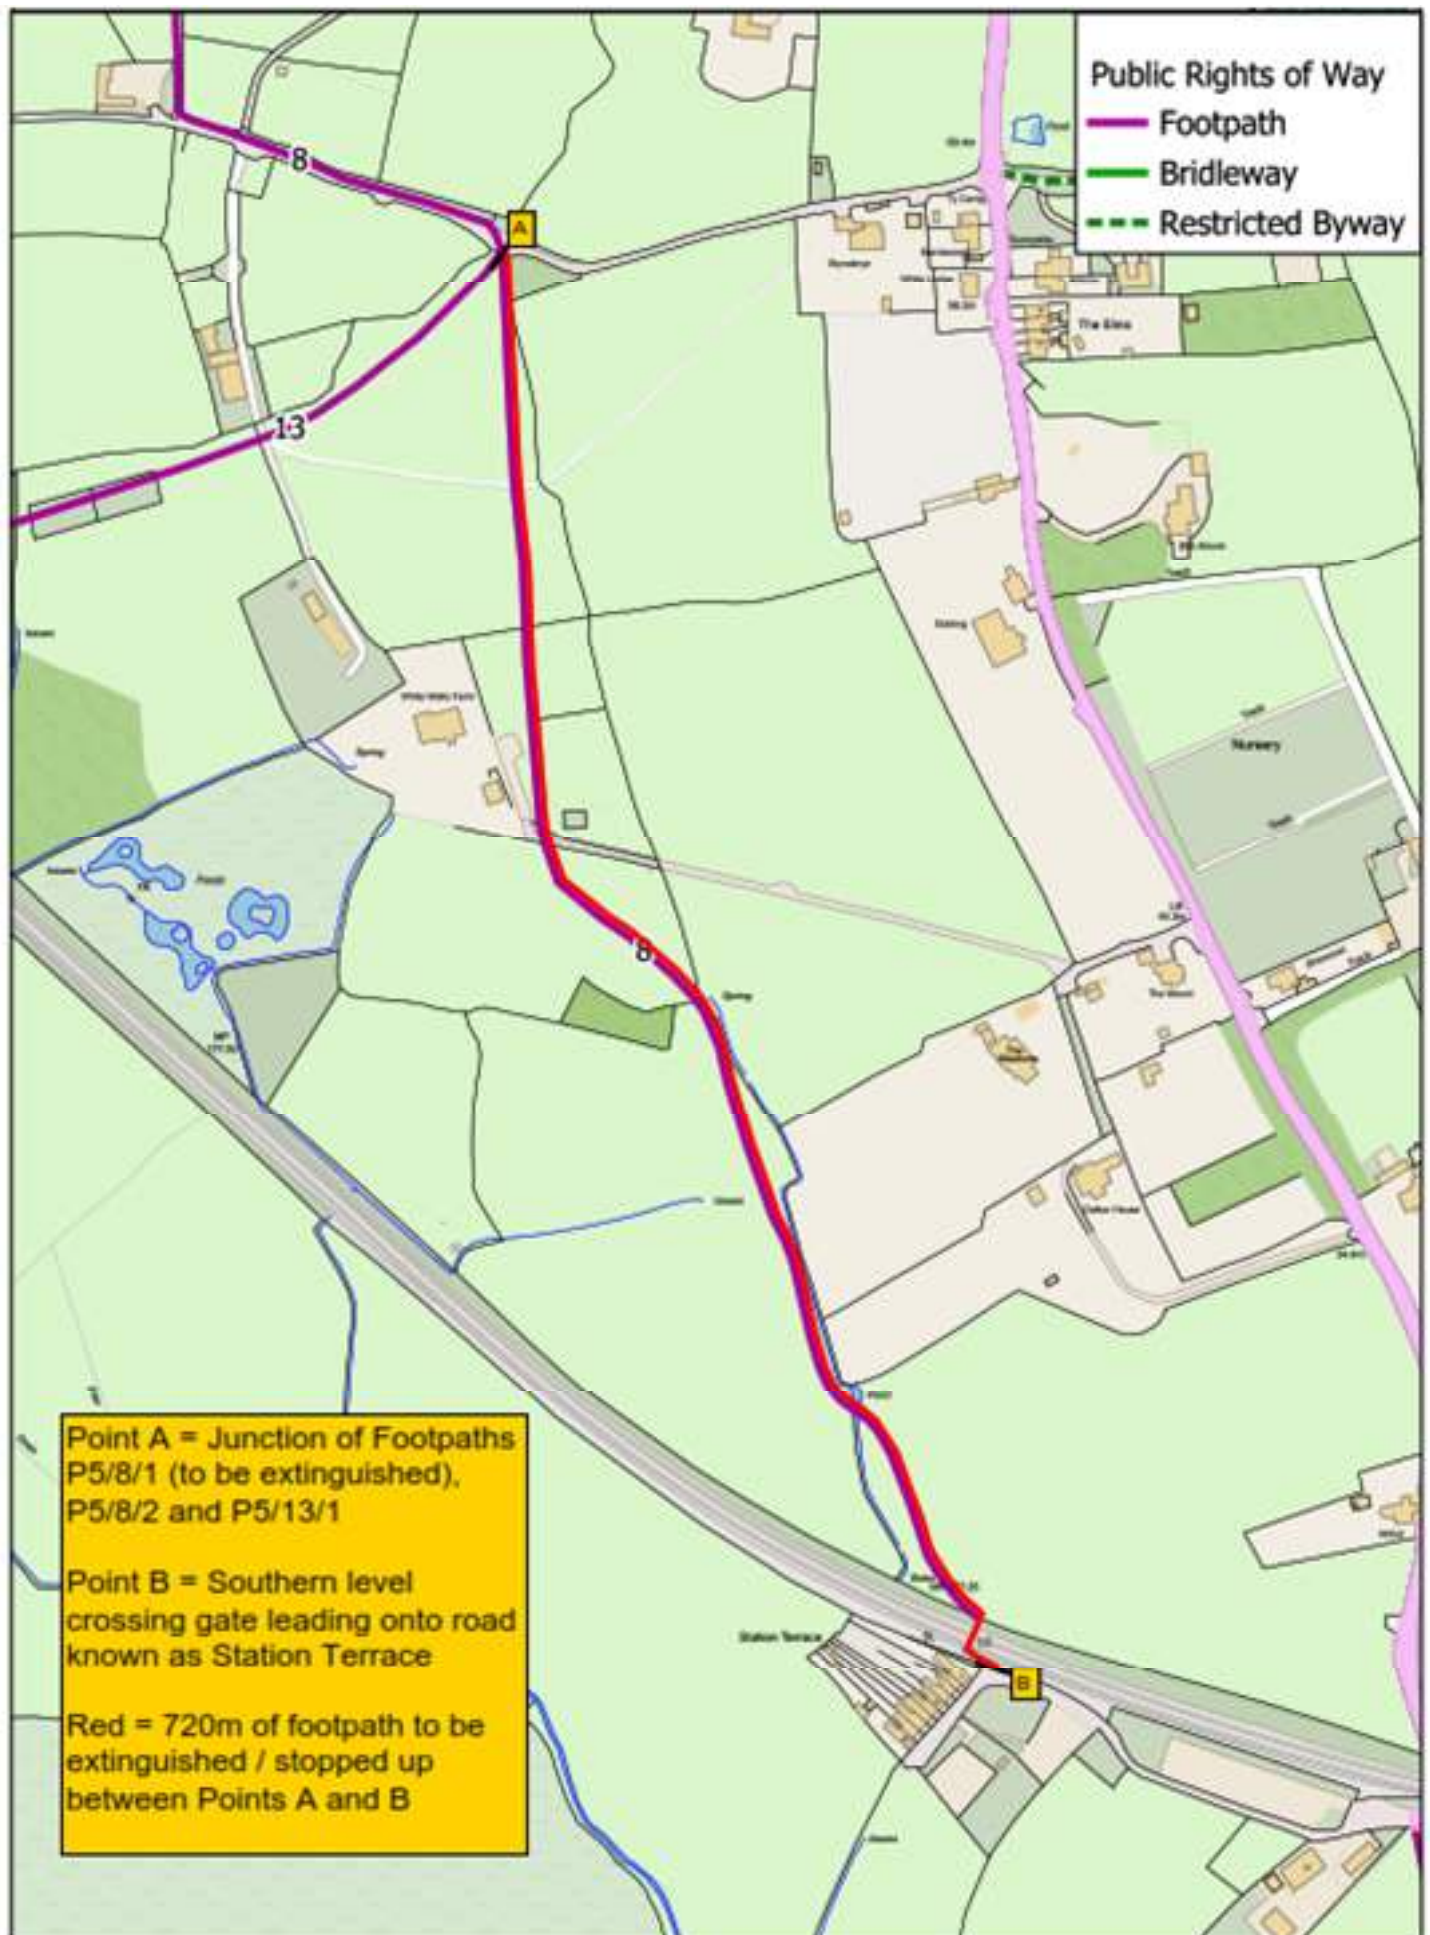
## Station Terrace Level Crossing – Extinguishment Plan

The length of footpath to be extinguished would be 720m from the junction of footpaths P5/8/1, P5/8/2 and P5/13/1 to the southern level crossing gate leading onto road known as Station Terrace. Please see the last page of this pack for an extinguishment plan

Therefore, for the reasons above, the only option for NR to pursue an extinguishment / stopping up of the entire length of footpath P5/8/1 as demonstrated by the accompanying plan using the powers of the Highways Act 1980.

The entire length is to be stopped to not only close the level crossing under safety, but also to assist the landowners with their privacy concerns and to follow guidance of DEFRA so not to create cul-de-sac public rights of way.
